NASA CR-132645

BORON/ALUMINUM SKINS FOR THE DC-10 AFT PYLON

FINAL REPORT

Prepared Under Contract NAS1 13029

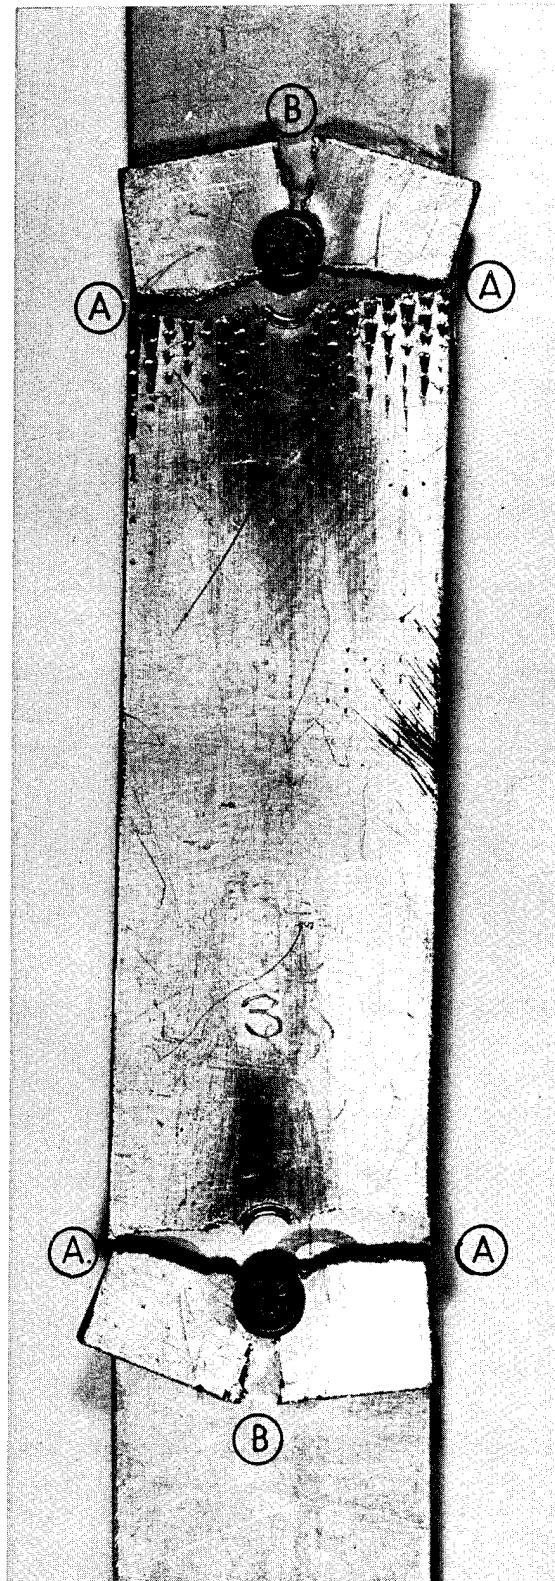
Figure 74 Mode of Failure of Bolt Bearing Specimen

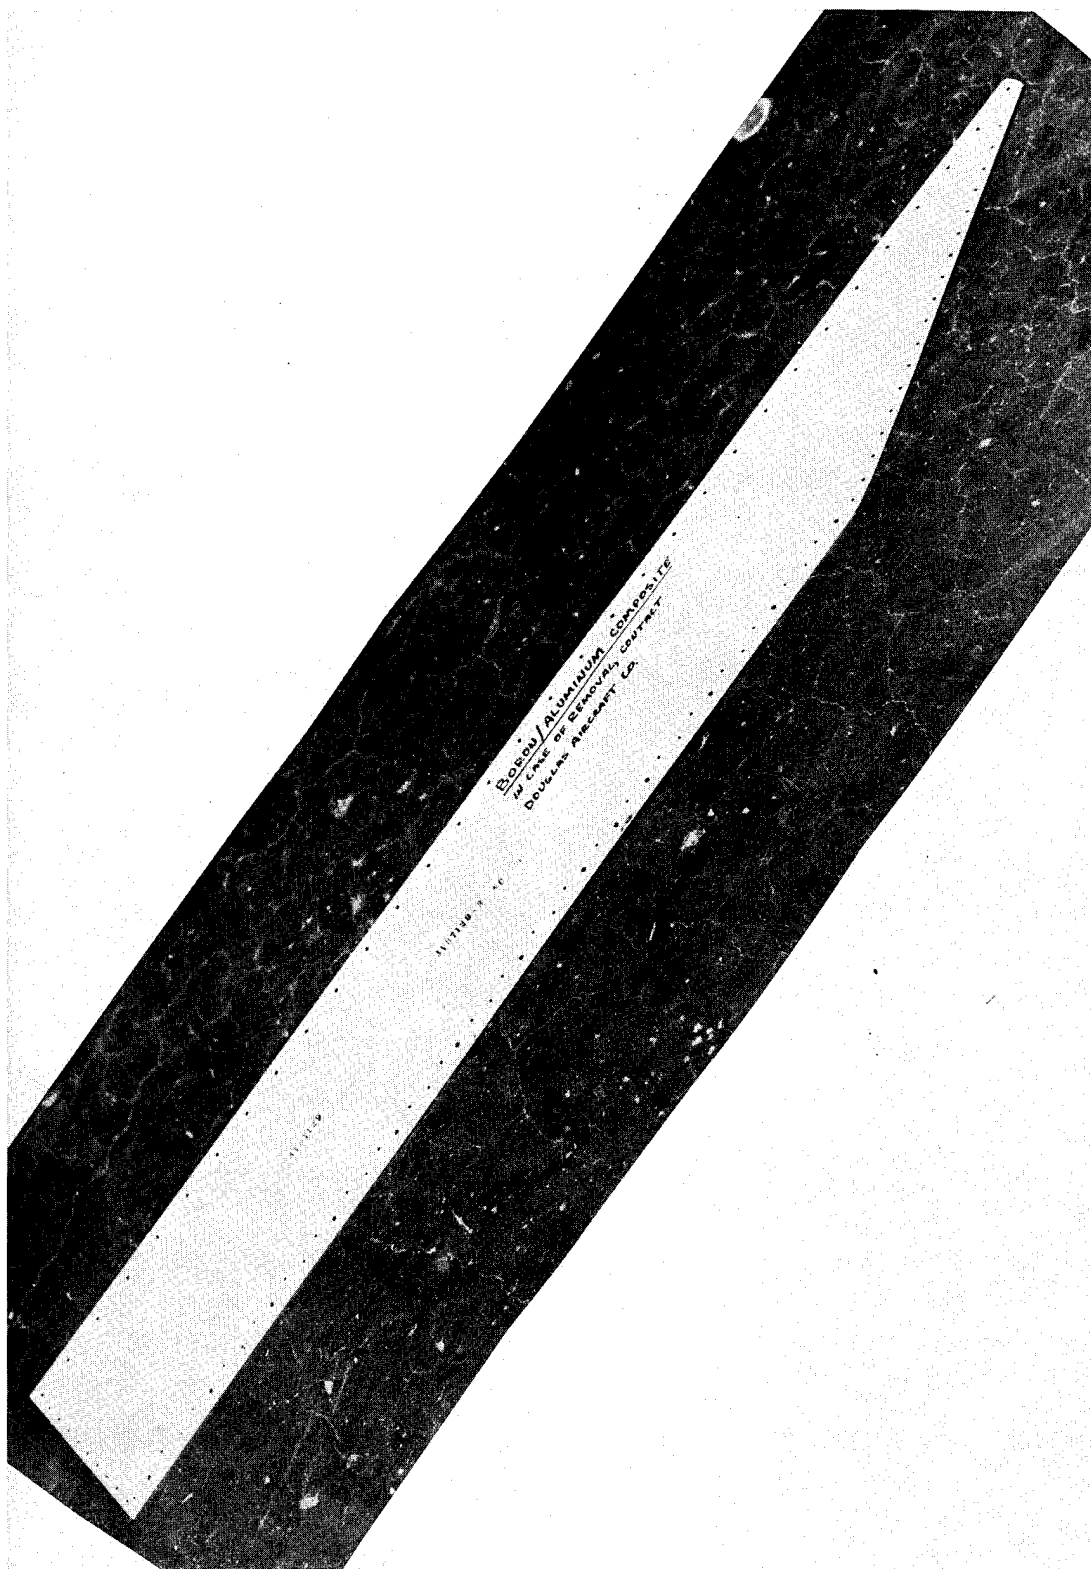
Figure 83 Boron/Aluminum Aft Pylon Skin-Edges and Corner Trimmed and Holes Punched
